Fines Preservation

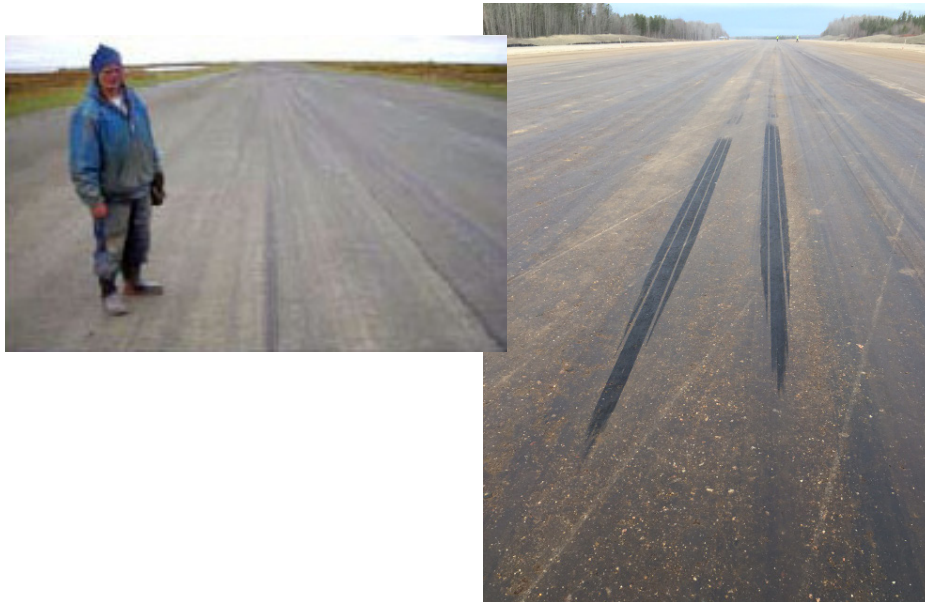
During an inspection of a EK35 treated gravel runway conducted by a third party engineering firm, it was concluded that "All airside surfaces are free from any visual evidence indicating lack of strength in the pavement structure." The report continues to state that "The touchdown zone surfaces for the runway are hard enough to show rubber loss from the aircrafts wheels during landing."
