SECUR System Case Study

North Slope Alaska Runway Stabilization

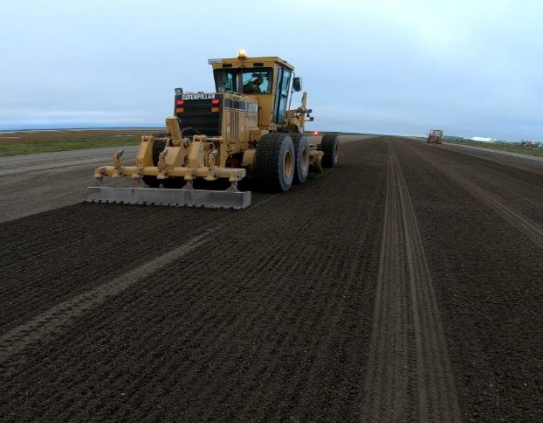
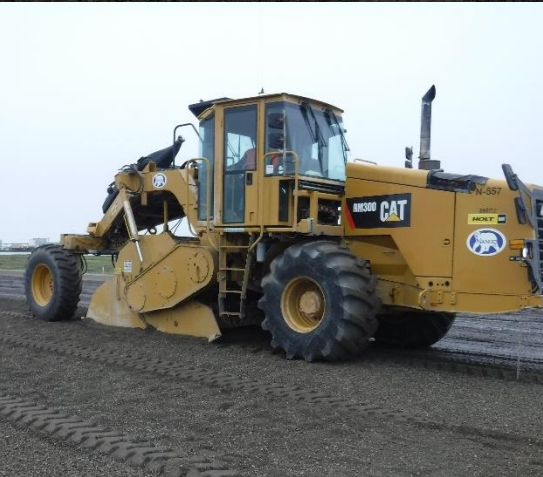
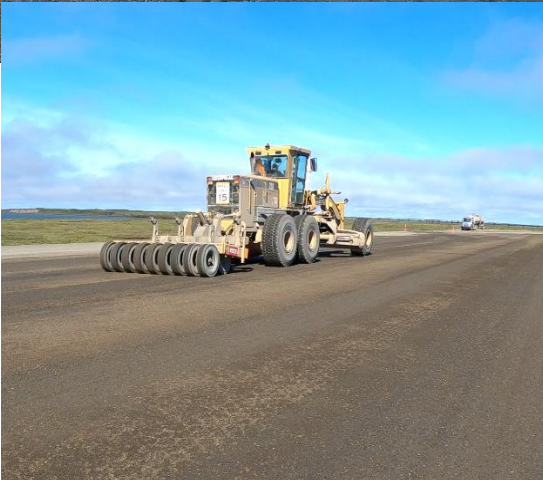
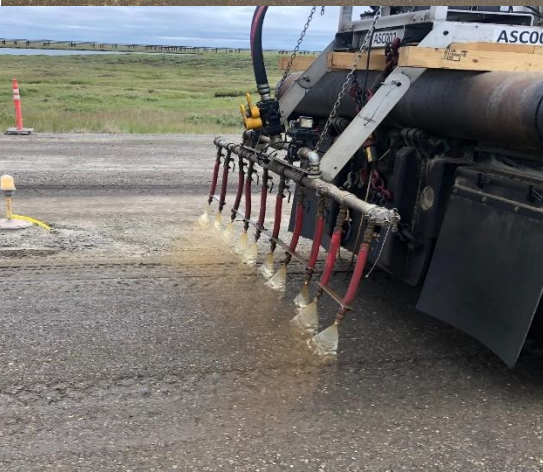
A large oil producer located in the North Slope of Alaska, was seeking a solution to stabilize their gravel runway infrastructure to facilitate year-round safe operations of Dash Q400, 107 Hercs, C-130, and DC6 aircrafts. In addition to a stabilized runway surface course, the Q400 operators required that the treated gravel surface be exposed during the winter months instead of using a snow packed surface.

The major issues with the existing runway were major loss of surface fines and poor operating conditions/strength during thawing and periods of heavy rainfall. Due the remoteness of this facility, there are no permanent roads connecting to other North Slope Infrastructure, so a reliable runway is of critical importance to their operations.

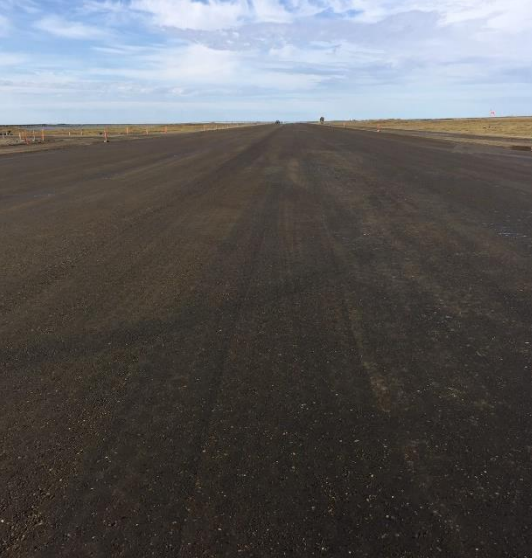
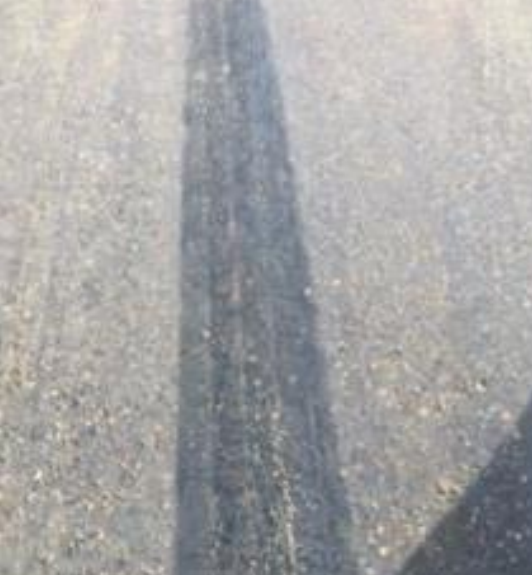
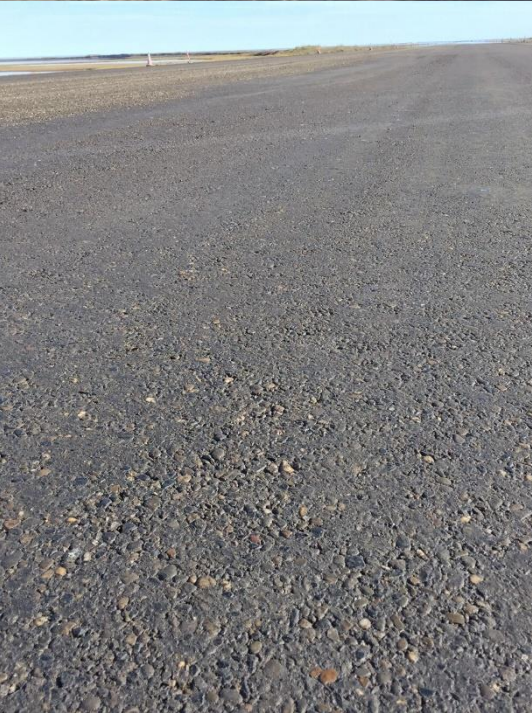
The airport's construction and maintenance crew performed the SECUR System installation with the assistance of Midwest's onsite technical team. To expedite the installation, a CAT RM300 reclaimer was used to incorporate the EK35 into the surface course layer.

1. Loosen the existing surface to a depth of 4"
2. Bring material to optimum moisture content
3. Apply 40% of the total recommended EK35 to the runway surface using E-Sprayer
4. Incorporate the EK35 into the upper 4" with CAT RM300
5. Apply an additional 40% of the total recommended EK35 to the runway surface using E-Sprayer
6. Incorporate the EK35 into the upper 4" with CAT RM300
7. Grade and shape the runway surface with proper crown
8. Compact the treated surface with wobbly wheel
9. Apply the remaining 20% of the total volume of EK35 as a seal coat
10. Continue compaction with wobbly wheel

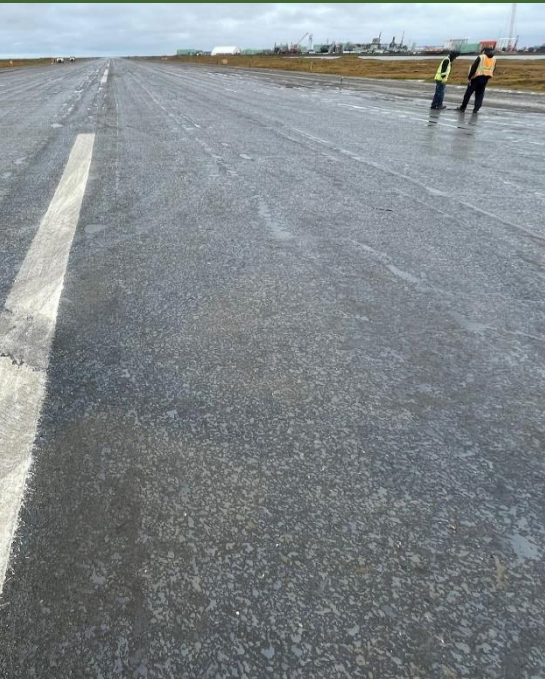
The installed SECUR System created a tightly bound, hard surface runway that achieved and exceeded the customers requirements. Shortly after construction, flight testing was successfully performed with the Dash Q400 aircraft to confirm the new runway was suitable for operations. CBR test results provided by the runway operator indicates that the stabilized surface far exceeded the minimum strength requirements. Due to the bound surface and moisture repellent properties of the SECUR System, the runway performed great throughout the winter and subsequent thaw even during extremely wet conditions.

Traditional Gravel Runway Upgraded to a SECUR Stabilized Runway
