# NaturalPaving Case Study Stabilization of Utility Access Roads and Pads

### **Project Background**

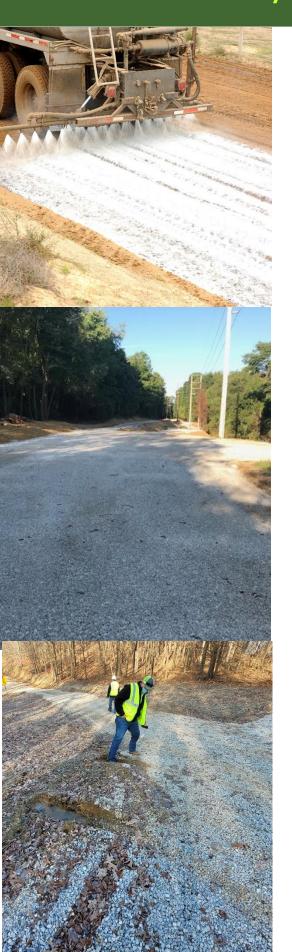
The utility company was very satisfied with the outcome and were able to perform all their work without issues or concerns about the integrity of the stabilized road and pads. To demonstrate the effectiveness of the SSEF89PBc stabilization, the photo on the left shows where a heavy truck went off the stabilized area and immediately sank almost 12" into the native soil. Without a quality stabilization design and installation, the utility company would not have been able to perform their needed work.

After the contractor performed their initial earthwork and shaped the roads and pads, SSEF89PBc was applied and incorporated into the upper 6" of the newly cut surfaces. In areas that couldn't be reached by truck, SSEF89PBc was carefully hand sprayed to ensure a uniform application. The SSEF89PBc treated surfaces were immediately graded to the design profile and compacted. Following compaction, the surface was not trafficked for several days to allow the SSEF89PBc treated layer to begin the curing process. Before the curing process was complete, a 1" thick layer of #57 stone was evenly spread on the treated surfaces and compacted to create an embedded aggregate wear course for all-weather friction. The surfaces were finished with a topcoat of Soil Sement Engineered Formula 69PBc to further lock the embedded aggregate into the surface.
