NaturalPave Case Study

Evaluating Eco-Pave Stabilized Roads After 1 Year

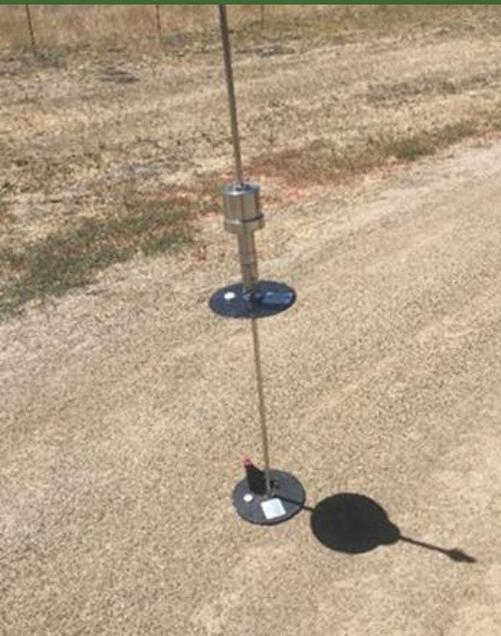
The Dynamic Cone Penetrometer readings were plotted versus depth to confirm the depth of the Eco-Pave stabilization. The DCP is a portable, handheld device used to measure the strength and thickness of soil layers. The results from each of the DCP tests can be easily converted to a California Bear Ratio (CBR). CBR values are a universally accepted strength measurement for soil layers. The stabilized layer will yield significantly higher CBR values than untreated soil therefore allowing for the identification of different pavement layers.

Based on the readings collected, Midwest can confidently identify three distinct layers of pavement. The three pavement layers as follows:

- 0–4" = Eco-Pave Stabilized Surface Layer
- 4–6" = Transition Layer (between stabilized and untreated layer)
- 6–8" = Untreated Layer / Native Soil

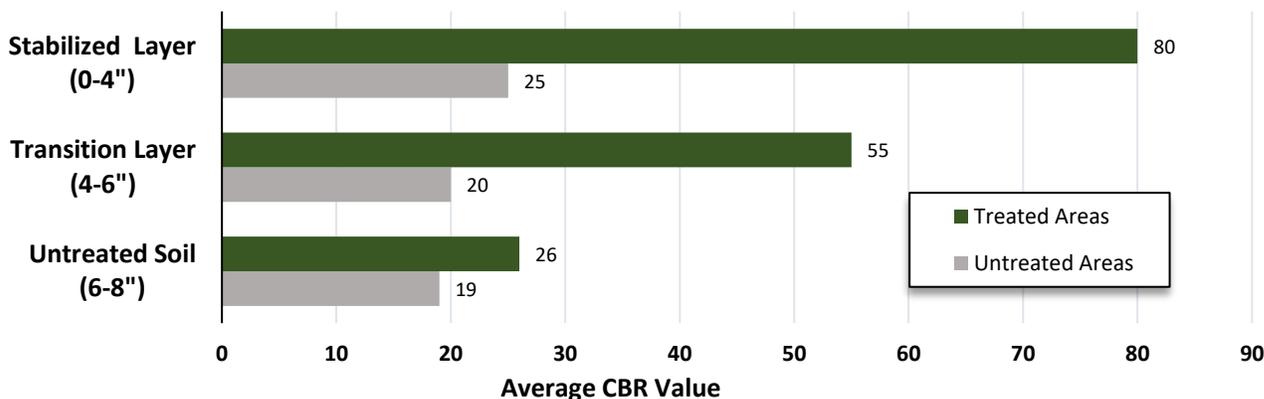
Comparison of Average CBR Values By Layer
Treated vs Untreated

Midwest analyzed the DCP readings to determine the strength improvements achieved and maintained one year after the Eco-Pave installation. Based on the 17 DCP readings collected, the average California Bearing Ratio (CBR) of each of the three pavement layers is plotted in the chart below.

The results collected one year after the installation indicate that **the Eco-Pave stabilized surface layer's CBR value increased by over 200% compared to the untreated, native soil.**
